Jondaryan Rail Loading Facility Air Quality Monitoring Results

Issue Month: March 2016

February 2016 TEOM Results

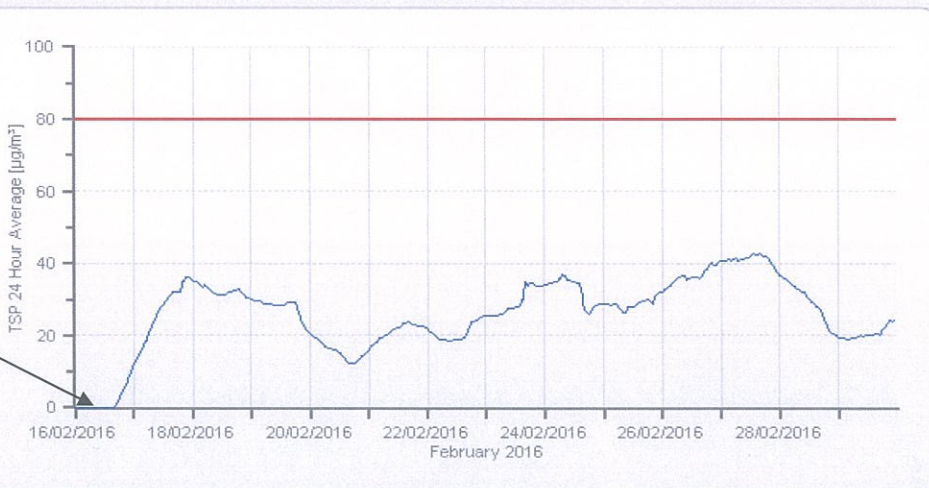
Figure 1: Jondaryan Township TSP continuous monitoring results for the period: February 2016

Comments: A TEOM located within the Jondaryan Township continuously measures Total Suspended Particulate (TSP) matter. When measured at a sensitive place, the maximum level of the release of TSP from the JRLF (24-hour average) is 80 micrograms per cubic metre (80µg/m³) as stated in the JRLF's EA. The TEOM's do not distinguish between particulate matter sources. The predominant wind directions for February 2016 were from the east (63.0%), south-east (18.5%) & north-west (7.4%). The predominant wind speed for February was calm to light winds. The TEOM unit was operational for approximately 42% of the sample period.

TEOM unit overheated prior to the beginning of February. Temperature configuration of the unit has been adjusted to reduce the likelihood of a similar occurrence in the future. Investigations are continuing into the improvement of fault notification.
