Jondaryan Rail Loading Facility Air Quality Monitoring Results

Issue Month: August 2015

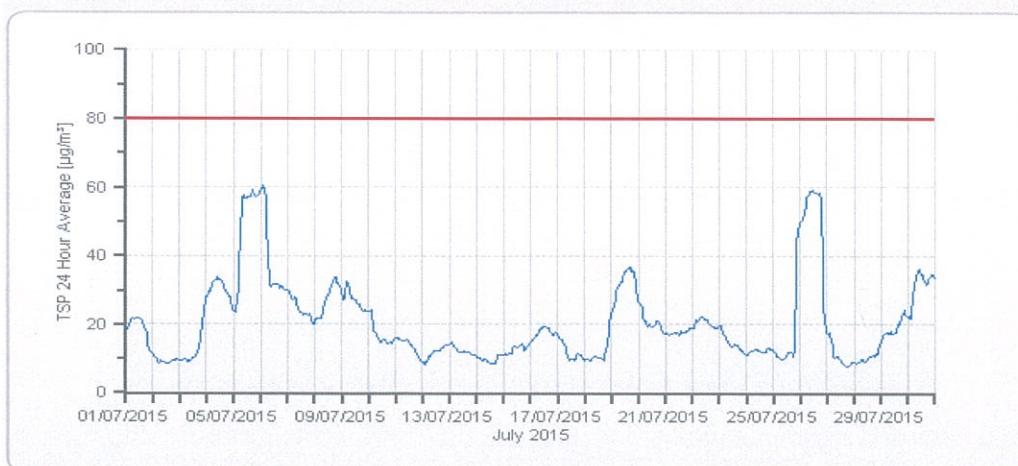
Figure 1: Jondaryan Township TSP continuous monitoring results for the period: July 2015

Comments: A TEOM located within the Jondaryan Township continuously measures Total Suspended Particulate (TSP) matter. When measured at a sensitive place, the maximum level of the release of TSP from the JRLF (24-hour average) is 80 micrograms per cubic metre (80µg/m³) as stated in the JRLF's EA. The TEOM's do not distinguish between particulate matter sources. The predominant wind directions for July 2015 were from the east (21%), west (17%), south-west (15%) & south (11%). The predominant wind speed for July was calm to light winds. The TEOM unit was operational for >99% of the sample period.
